# A RECLAMATION PLAN FOR BEACON PIT MINE BATTLE MOUNTAIN, NEVADA

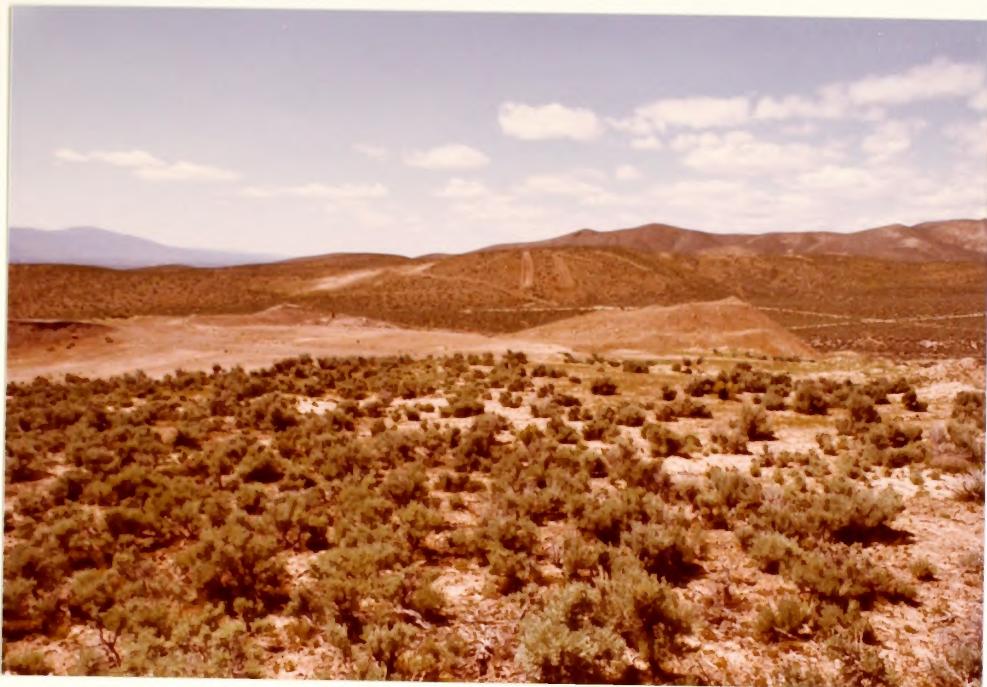
GENERAL VIEW OF PIT AREA

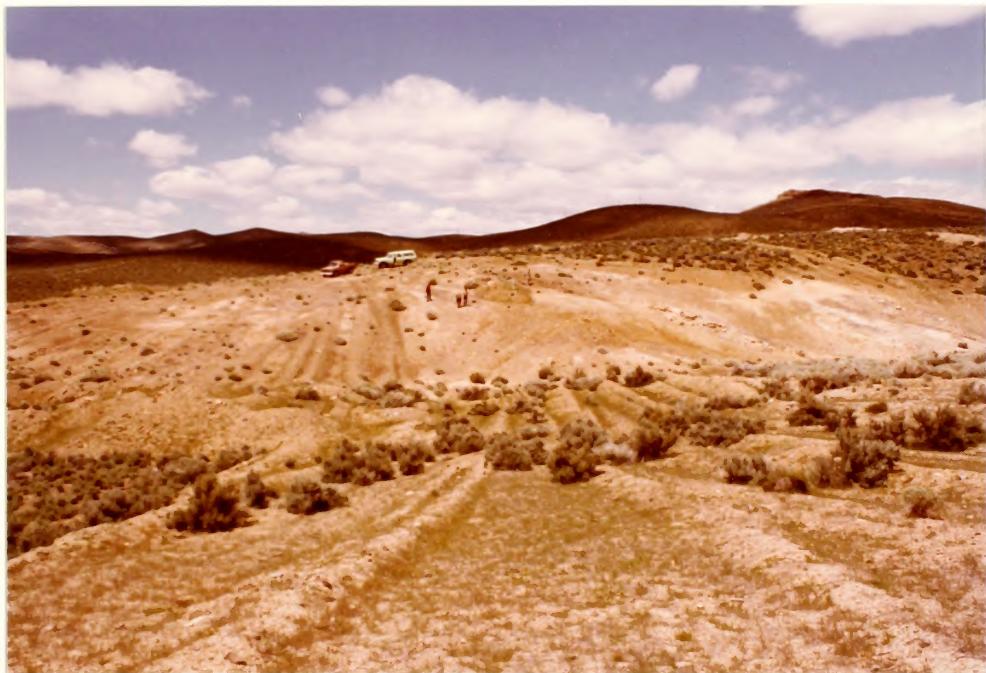
OVERALL VIEW OF TREATMENT A LOOKING NORTH

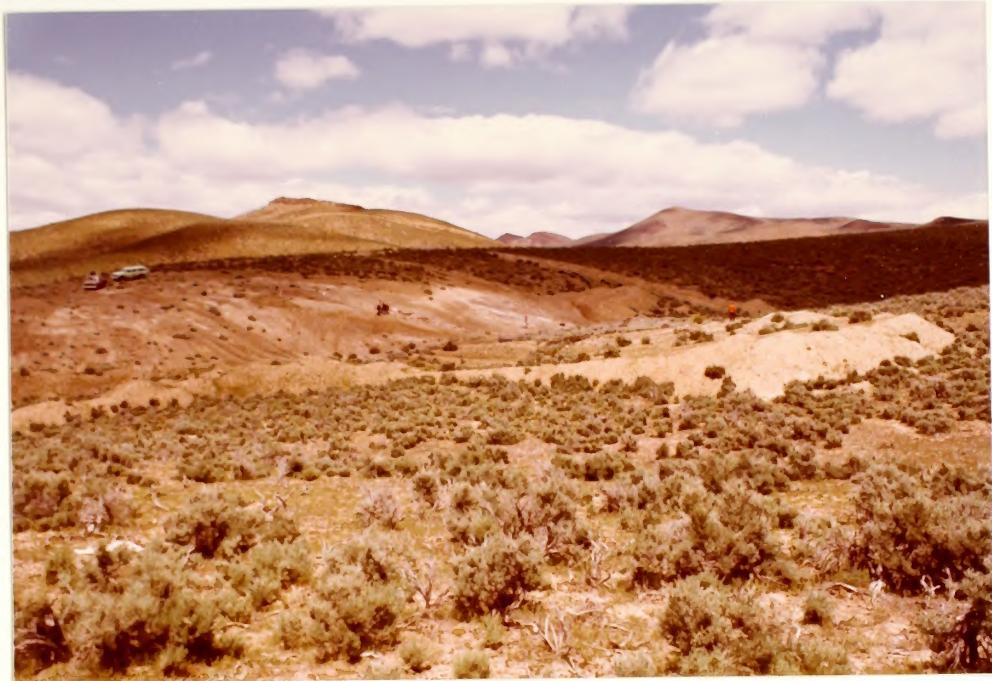
Taken in Area A, looking approximately north across the drainage area. Majority of top soil is on the south side of drainage. Drainage is blocked near right side of disturbed area.

Reshape and smooth the disturbed area, filling local depressions and cuts so as to blend the scraped area with the undisturbed margins. Remove an appropriate amount of topsoil and overburden from the east end of the area and along the drainage. Spread the material over the scraped area.

Rip the entire area to bedrock or to a depth of 24 inches whichever is less, with 48 inch spacing.

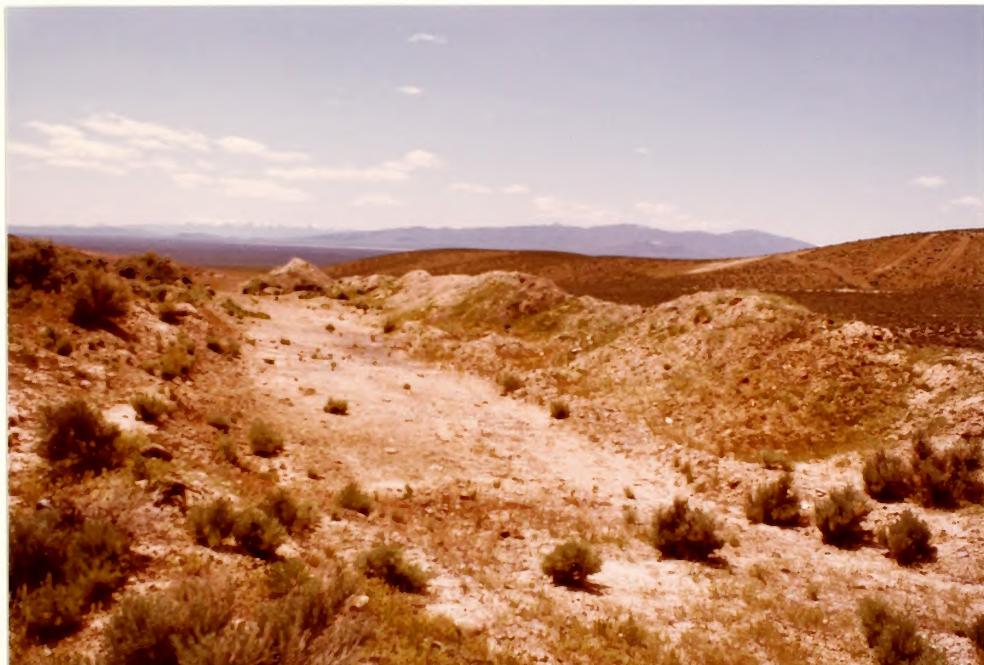
Taken near spot symbol 1, showing a dozer trench with berms of top soil that have been pushed aside.

Site # 1. This site consists of several exploration cuts adjacent to Area A. Shaping and preparation here will consist of smoothing side and end berms.

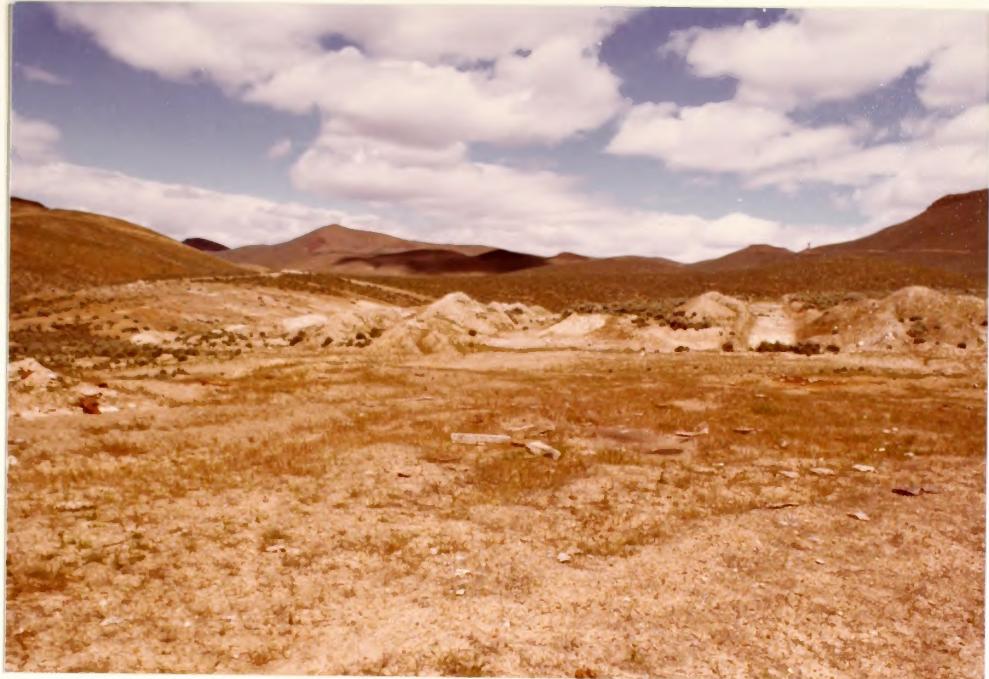
Area B on east side of pit area on proposed reclamation site, Area A is seen in the background.

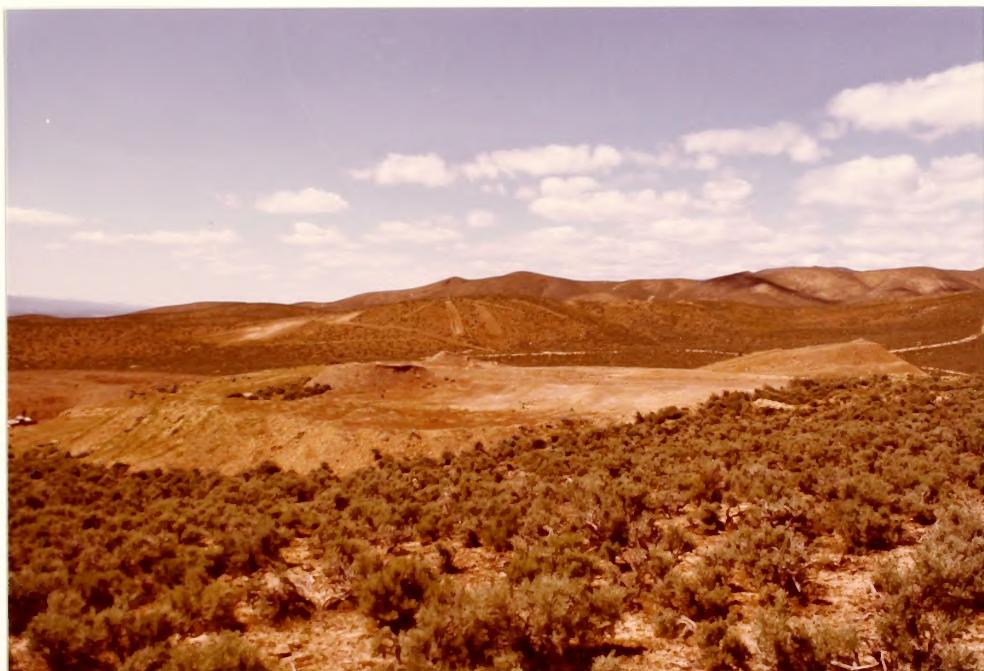
Area B, brush in foreground is outside treatment area, notice topsoil more or less stockpiled.

Topsoil and overburden material stockpiled at the south end of the bench will be spread across the bench area.

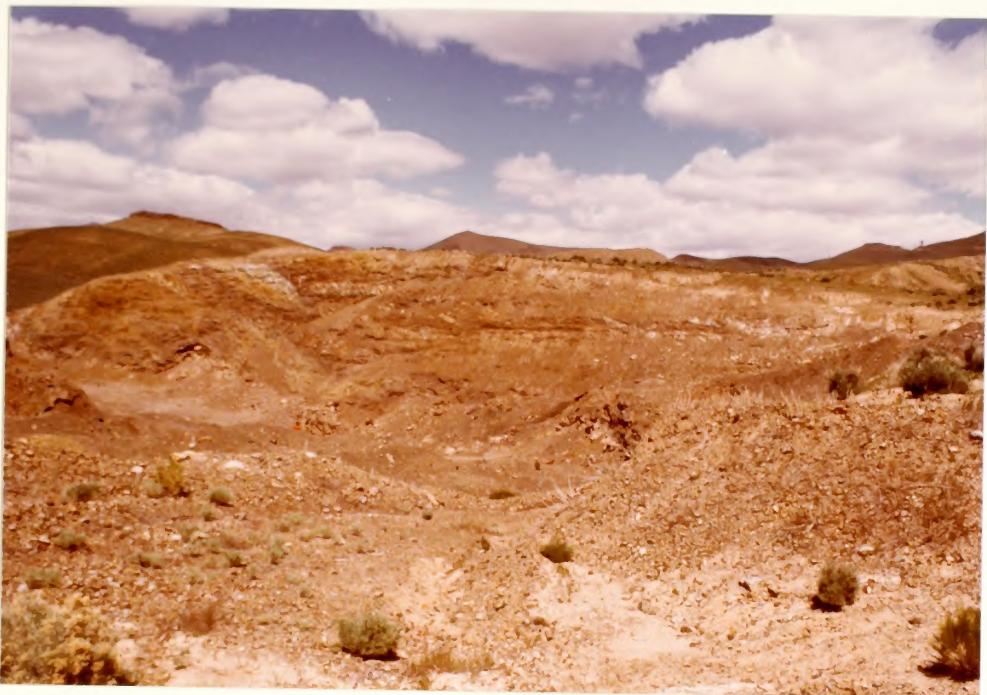
Standing in Area C looking into pit area.

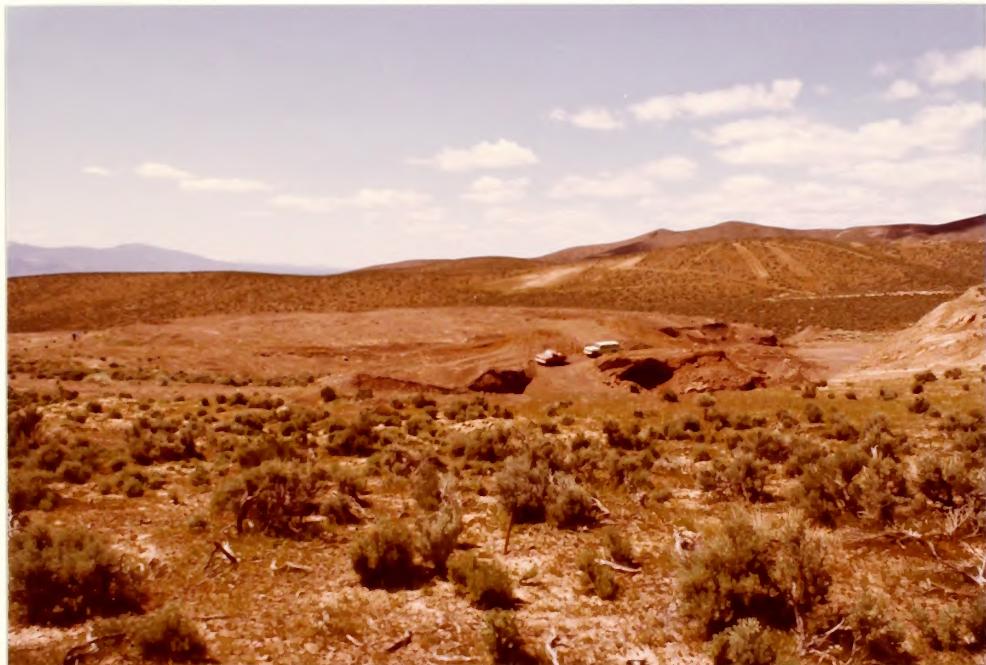
Taken in Area C, looking north into the pit area, high wall on the right hand side of picture.

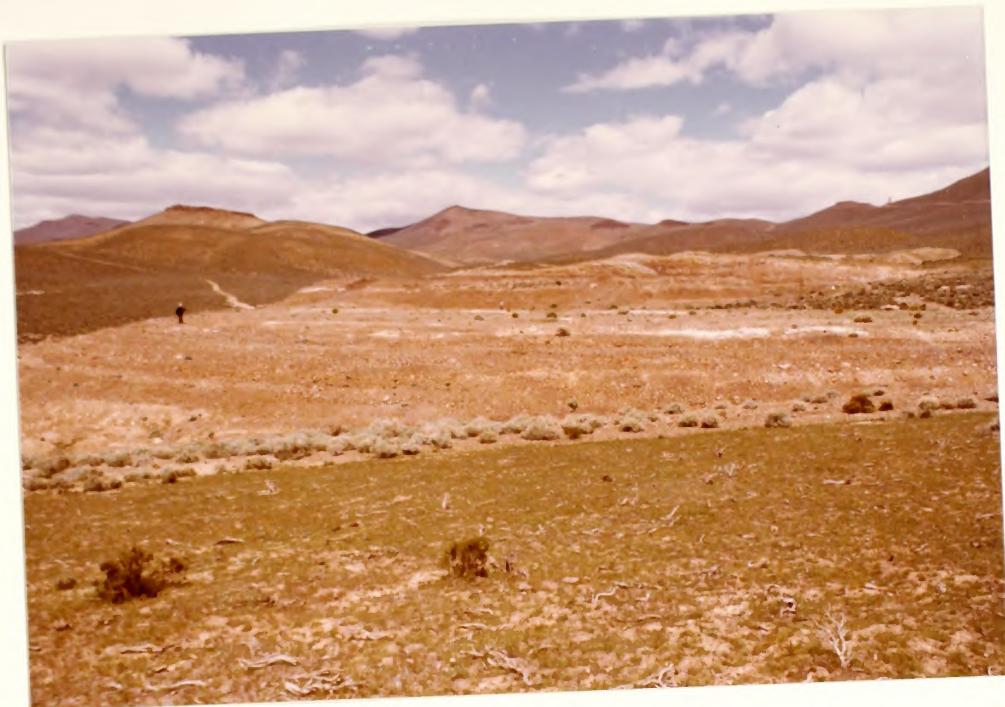
Area C looking north, giving an overall view, showing the tailings dump.

Reshape the dump area. Fill local depressions or cuts to produce even contoured slopes of less than 30 percent and blend the dump into the surrounding undisturbed land.

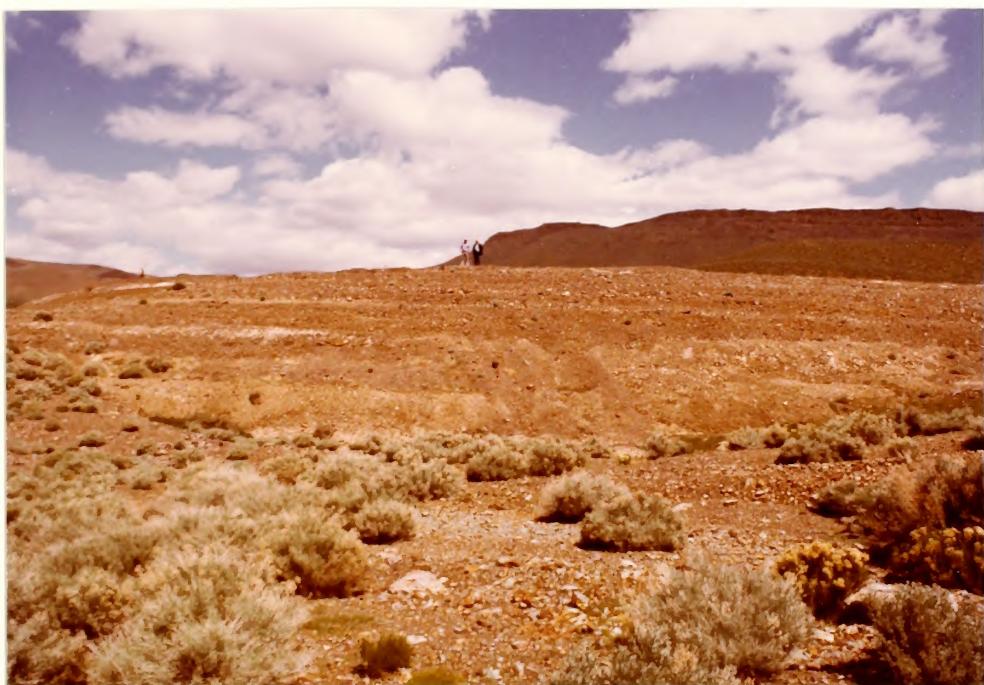
Taken from the drainage in Area C, looking southeast toward spoil overburden fill.

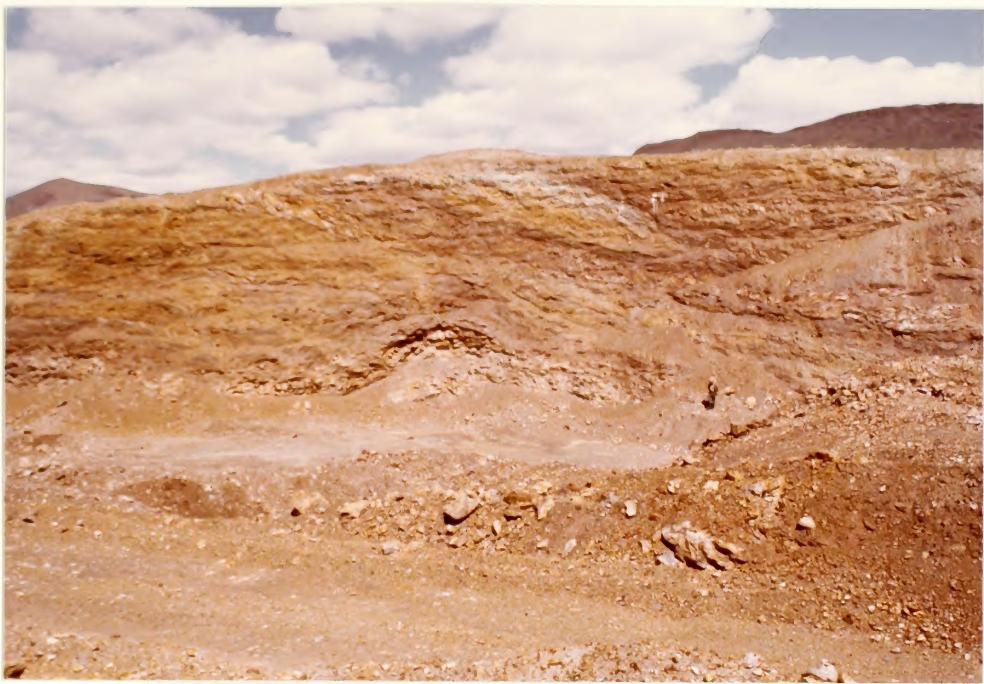
Looking east from the pit area, showing the high wall.

The high wall and smaller trench-pit will be left intact. Other parts of the main pit will be smoothed and reshaped. The south wall is to be graded to an even slope of not more than 30 percent ( $18^{\circ}$ ).
